State of Utah DEPARTMENT OF NATURAL RESOURCES DIVISION OF OIL, GAS AND MINING

Site Inspections; UMETCO Minerals Corporation; Calliham (M/037/023), Wilson-Silver

Bell (M/037/027), and Deremo-Peterson (M/037/025) Projects, San Juan County, Utah

Photographs M/037/023, M/037/027, and M/037/025 Calliham, Wilson-Silver Bell, and Deremo-Peterson Mines

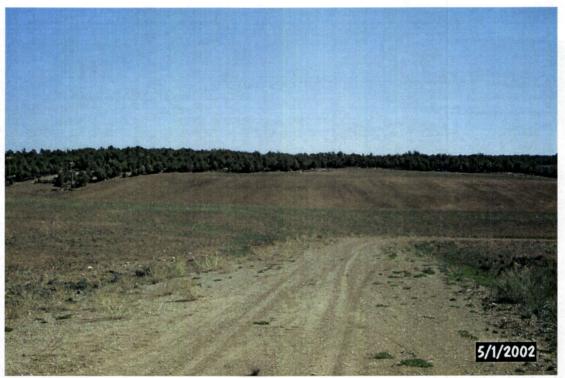
Photos 1 through 3 show the mine site. It has been graded to fairly gentle slopes that match surrounding topography quite well. The area was seeded in the fall of 2000, and the vegetation is progressing well. From a distance, it looks like there is little vegetation on the slope shown in Photo 1, but this slope actually has good vegetation cover considering there has only been one full growing season since the site was seeded. In my opinion, the vegetation on this site will continue to grow, and the operator should have little trouble meeting bond release criteria. There are some rills on one of the slopes, but they are relatively minor and should heal once vegetation is better established.

Photo 1. Calliham Mine looking toward the waste pile. There are a few rills on this pile.

I am fairly confident there will be adequate vegetation at the Calliham Mine, but we should still check it whenever possible.

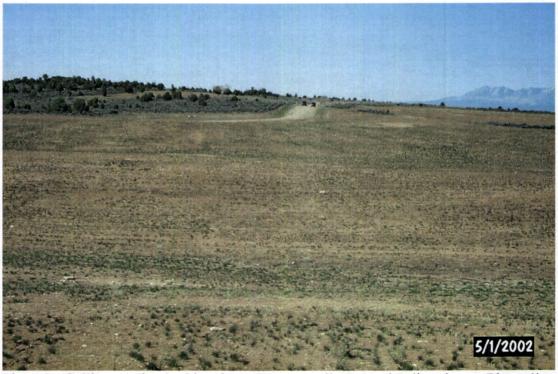
Photo 2. Calliham Mine looking from the waste pile (opposite direction as Photo 1).

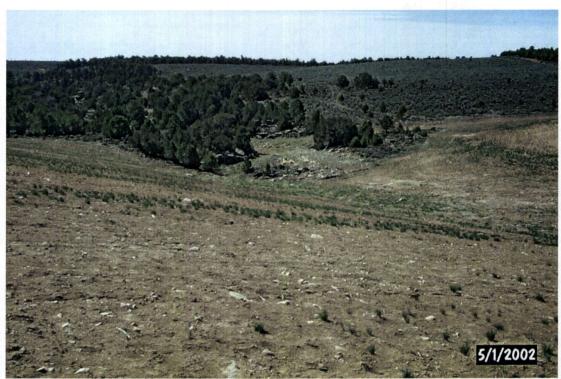
Photo 3. Calliham Mine looking toward the top of Wildhorse Canyon.

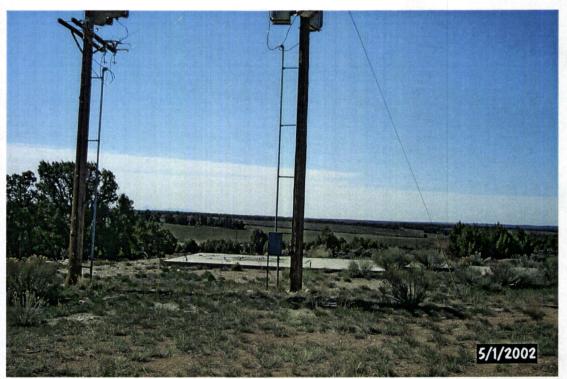
Some of the buildings and other structures, including power poles, erected for the mine have been left at the land owner's request. The power poles have Pacificorp labels, but according to Mr. Bates and Mr. Barnett, Utah Power and Light does not claim them and is not willing to replace them. Several of the poles leading into the mines have broken, and because they are not functional for the postmining land use, they need to be removed. There are some other poles with transformers near some of the vent shafts, and these appear to still be usable. The land owner has also requested that these be left. One of these vent shafts is shown in Photo 4.

Photo 4. Vent shaft near the Silver Bell Mine. The concrete pad is a compressor platform.

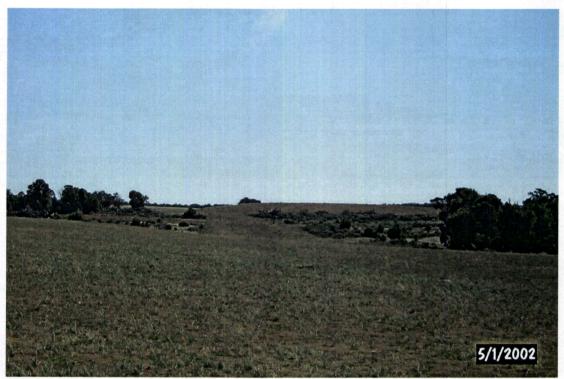
Vegetation on the waste disposal area at the Silver Bell Mine appears to be doing very well. I am a little more concerned about vegetation at the Wilson Mine. Although it is more sparse and consists of more sweet clover than I would like to see, I believe it will probably progress and that reseeding will not be necessary. Photos 5 and 6 show the Silver Bell Mine waste disposal area.

Photo 5. Silver Bell Mine waste disposal area with Wilson Mine in the background.

At the Wilson-Silver Bell Mines, the operator needs to remove the power poles leading to the mines. We will want to monitor vegetation, especially on the waste disposal area at the Wilson Mine, although I believe the vegetation will ultimately succeed.

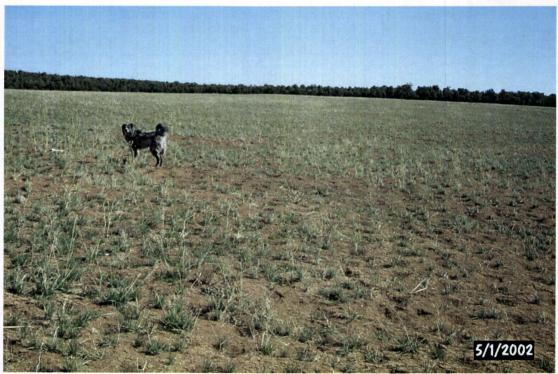
In Photo 6, one can see the small depressions that were made when the site was seeded. This was done with the idea that the depressions would increase water retention and vegetation establishment and growth. We could not tell that there was greater establishment in the depressions compared to outside the depressions; however, I suspect that they increase the amount of moisture held on the slopes and improve growth. Larger depressions, such as those the operator used at the Sunset Mine, may be more beneficial.

Photo 6. Silver Bell Mine. Note the small depressions in the soil.

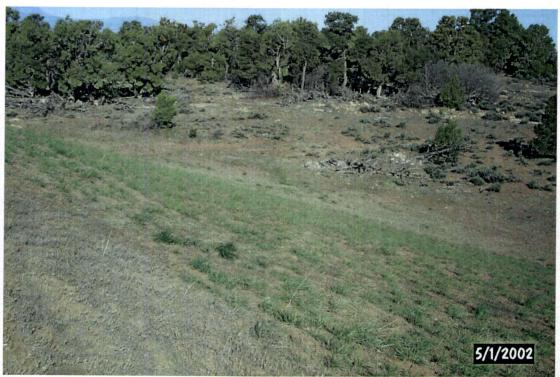
The Deremo-Peterson Mine was seeded with grasses at the land owner's request. Seeding was done in 1999. The north side of the waste pile is well vegetated, but other portions of the pile have scattered vegetated areas (Photos 7, 8, and 9). There was an ore pad north of the waste disposal

Photo 7. Deremo-Peterson Mine, north side of waste disposal area. Note the amount of perennial vegetation compared to photos below.

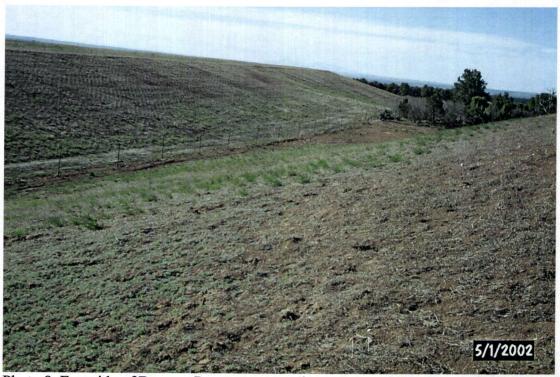
Vegetation establishment and growth at the Deremo-Peterson site has almost certainly been adversely affected by lack of rainfall, but considering how well the two nearby sites have done, this cannot be the only reason for the lack of vegetation in this area. The site does not meet the revegetation criteria for release.

Photo 8. East side of Deremo Peterson waste disposal area. Note the relatively small amount of perennial grass cover compared to the north side of this pile. The fence is at the Colorado state line, so the pile in the background is in Colorado.

I suggest that the operator wait until fall then reseed those areas where there is minimal perennial vegetation. Because of the number of weeds that have become established, I have some concerns about reseeding, but I believe there is not enough perennial vegetation for it to spread and meet bond release criteria without supplemental seeding.

Redisturbing an area like this tends to further increase weed growth, so I suggest that the operator either not use fertilizer or minimize the amount of fertilizer used. I do not recommend that the operator use herbicides for weed control, but that would be an acceptable option. To decrease the number of weed seeds that could germinate next year, the operator might use a broadleaf herbicide on the weeds this summer before they are able to set seed. Another choice would be to wait until next spring after the reseeded grasses have germinated and established then use an herbicide specific to broadleaf weeds. Although I have seen these methods used, the results have been mixed. I am not sure how much the herbicide applications improved grass establishment.

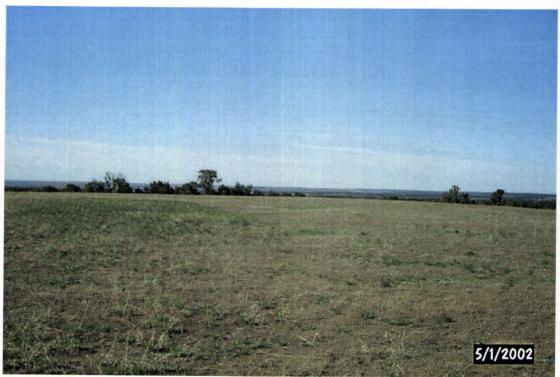
Photo 9. Top of the Deremo-Peterson waste pile.

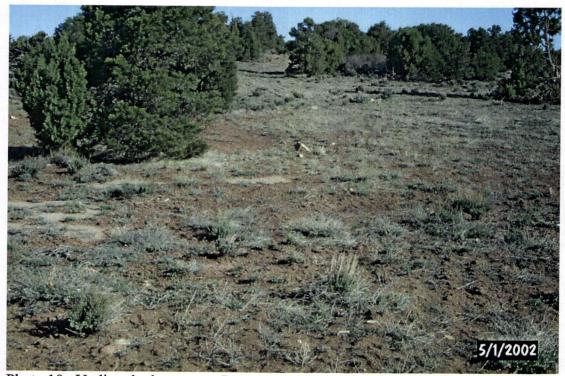
area, and it has little or no desirable vegetation. We were told that this area was essentially bedrock with just a couple of inches of soil placed on it. I also took a photo of a nearby undisturbed area for comparison (Photo 10). The undisturbed area also had little soil, but it may be unfair to compare a near-climax community to a site reclaimed three years ago.

Photo 10. Undisturbed area near Deremo-Peterson Mine.
